PHOTOGRAPHIC SURVEY OF THE LDEF MISSION

NASA Special Publication 531

Robert L. O'Neal

National Aeronautics and
Space Administration

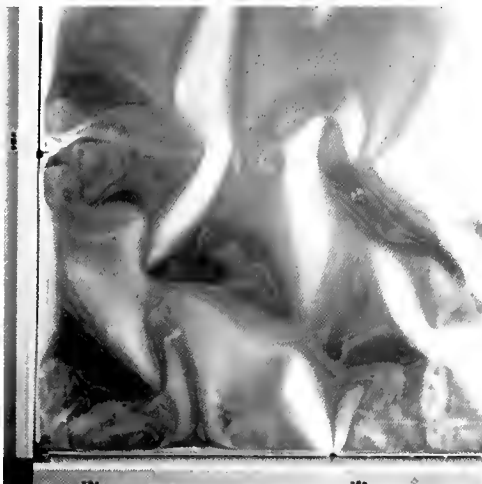
Figure 400
Photo No.: KSC-390C-2336.09
Dup. Neg. No.: L91-10429
LISAR No.: EL-1994-00605
Photo Credit: KSC
Photo Date: 3/27/90
Location: KSC SAEF II
Subject: Postflight Detail of Lower Left of Tray E2

Figure 400 (Postflight). This photograph is of the lower left one-sixth of the tray. The thermal cover appears specular with no apparent damage. The reflective properties of the uneven surface of the cover result in various light and color patterns. The locations of the Velcro attachment pads are visible.

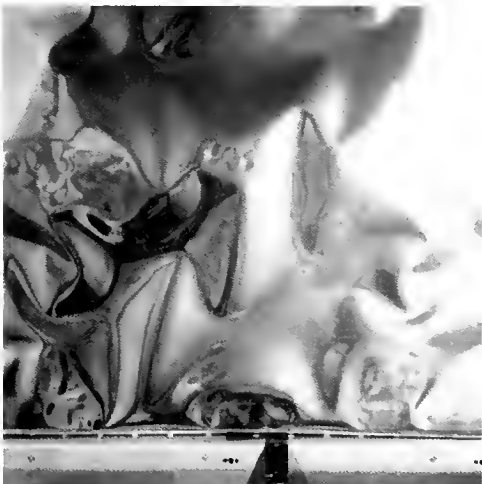
Figure 401
Photo No.: KSC-390C-2336.10
Dup. Neg. No.: L91-10430
LISAR No.: EL-1994-00617
Photo Credit: KSC
Photo Date: 3/27/90
Location: KSC SAEF II
Subject: Postflight Detail of Lower Center of
Tray E2

Figure 401 (Postflight). This photograph is of the lower center one-sixth of the tray. The thermal cover appears specular with no apparent damage. The reflective properties of the uneven surface of the cover result in various light and color patterns. The locations of the Velcro attachment pads are visible.

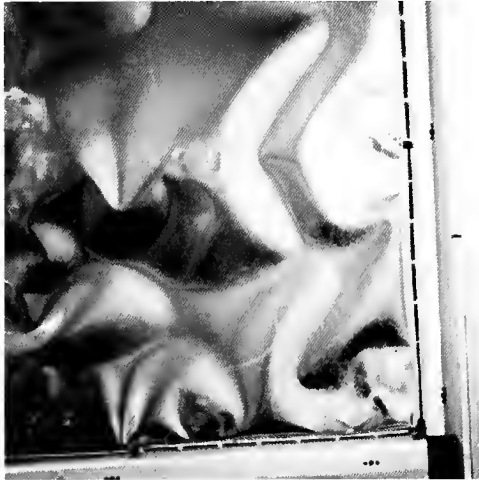
Figure 402 (Postflight). This photograph is of the lower right one-sixth of the tray. The grainy pattern in the surface finish, which is visible in the light reflection, was on the material prior to flight. The thermal cover appears specular with no apparent damage. The reflective properties of the uneven surface of the cover result in various light and color patterns. The locations of the Velcro attachment pads are visible.

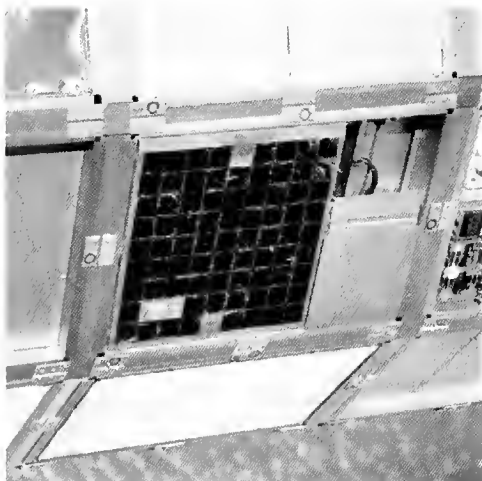
Figure 404
Photo No.: S32-77-067
Dup. Neg. No.: L90-10417
LISAR No.: EL-1994-00001
Photo Credit: JSC
Photo Date: 1/12/90
Location: KSC SAEF II
Subject: In-Flight Survey of Tray E3

Figure 404 (In Flight). The capture cells appear to be severely damaged. Fragments of the failed capture cell covers, which have curled into tight conical shapes, are attached to edges of the aluminum mounting frame. The capture cell mounting structure and calorimeter mounting plates are discolored; some areas have more pronounced discoloration than others. The canister for experiment S1002 is closed.

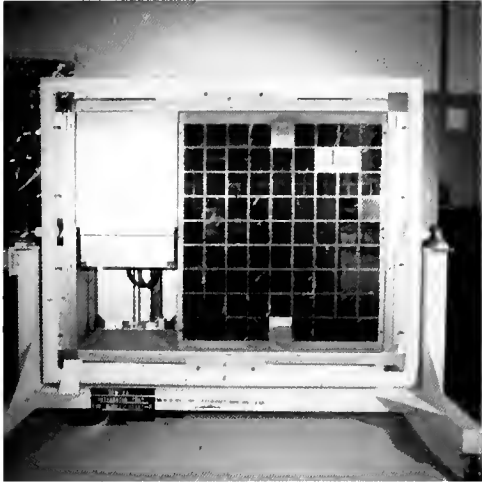
Figure 405 (Postflight). The capture cells have degraded and only 11 of the 77 metallized Mylar covers survived. There is a brown stain on the tray, the capture cell mounting, and the calorimeter mounting plates. The green tint on the right side of the experiment is a reflection of lights from an adjacent room. The canister for experiment S1002 is closed.

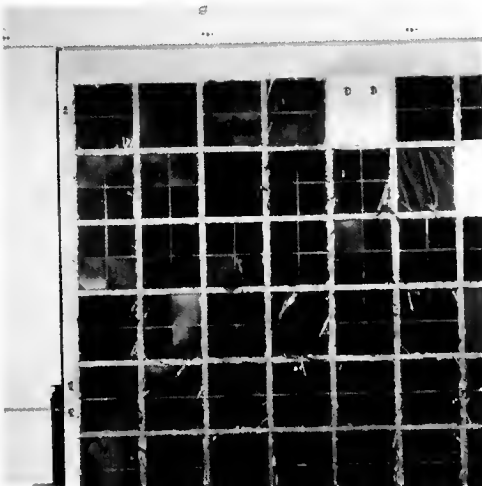
Figure 406 (Postflight). This photograph is of the upper left one-fourth of experiment AO187-2. Two capture cell covers are intact. The remains of the others are curled tightly and hanging from one edge. There is considerable discoloration on the upper mounting frame and on the calorimeter.

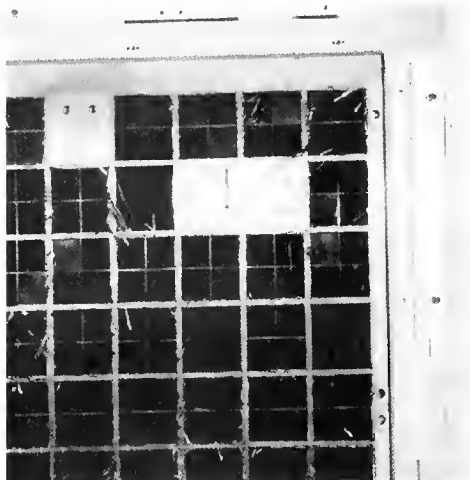
Figure 407 (Postflight). This photograph is of the upper right one-fourth of experiment AO187-2. Three capture cell covers are intact. The remains of the others are curled tightly and are hanging from one edge. There is considerable discoloration on the upper and right sides of the mounting frame and on the calorimeter.

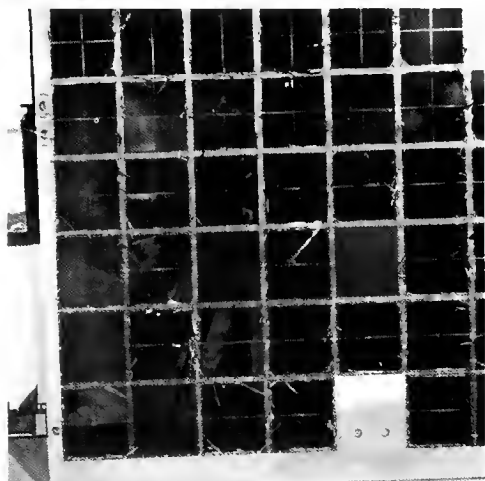
Figure 408 (Postflight). This photograph is of the lower left one-fourth of experiment AO187-2. Four capture cell covers are intact. The remains of the others are curled tightly and are hanging from one edge. There is considerable discoloration on the left and lower sides of the mounting frame and on the calorimeter. Note the reflection of the photographer.

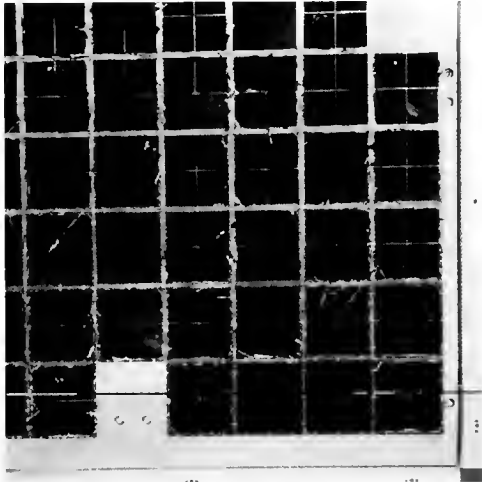
Figure 409 (Postflight). This photograph is of the lower right one-fourth of experiment AO187-2. Four capture cell covers are intact. The remains of the others are curled tightly and are hanging from one edge. There is considerable discoloration on the lower and right sides of the mounting frame and on the calorimeter. Note the reflection of the photographer.

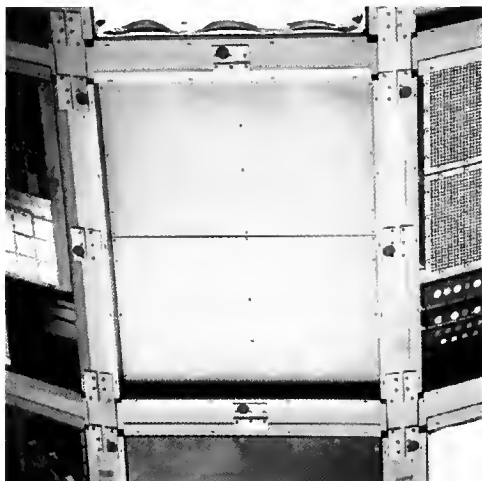
Figure 410 (In Flight). The greenish-gray and pink tints on the two debris panels are by-products of the chromic anodize coating process and are not attributed to contamination or exposure to the space environment. Discolorations are visible along some edges of the panels, thus indicating improper handling and cleaning after panel assembly.

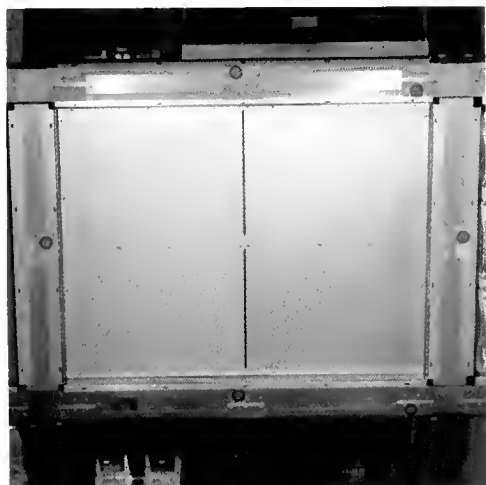
Figure 411
Photo No.: KSC-390C-832.03
Dup. Neg. No.: L90-13350
LISAR No.: EL-1994-00172
Photo Credit: KSC
Photo Date: 2/7/90
Location: KSC SAEF II
Subject: Postflight Survey of Tray E4

Figure 411 (Postflight). The greenish-gray and pink tints on the two debris panels are by-products of the chromic anodize coating process and are not attributed to contamination or exposure to the space environment. The fingerprints along the bottom edge of the panels that were observed in the in-flight photograph are still visible. The light band along the sides and across the bottom of the tray is caused by light reflected from the tray sidewalls.

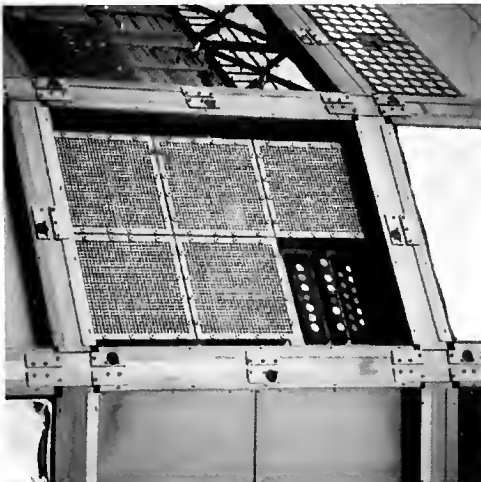
Figure 413
Photo No.: S32-77-050
Dup. Neg. No.: L90-10413
LISAR No.: EL-1994-00679
Photo Credit: JSC
Photo Date: 1/12/90
Location: KSC SAEF II
Subject: In-Flight Survey of Tray E5

Figure 413 (In Flight). In this photograph, the experiment hardware appears to be without physical damage. The blue is due to lighting. The exposed experiment test specimens and the fiberglass-epoxy mountings appear to have survived the mission. The colors of the fiberglass-epoxy mounting strip have changed from the typical greenish gray to a slate gray and the colors of the test specimen appear to be much darker than in the prelaunch photograph.

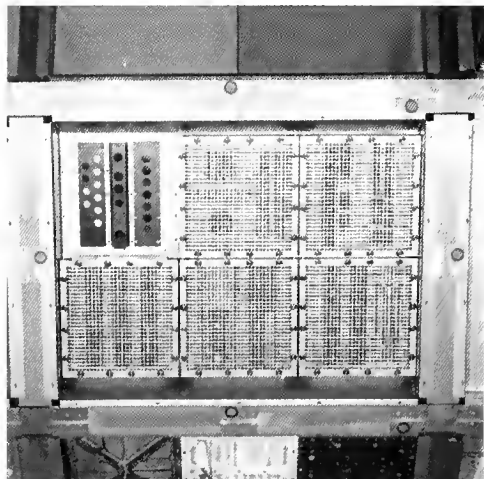
Figure 414
Photo No.: KSC-390C-1035.05
Dup. Neg. No.: L90-13450
LISAR No.: EL-1994-00183
Photo Credit: KSC
Photo Date: 2/9/90
Location: KSC SAEF II
Subject: Postflight Survey of Tray E5

Figure 414 (Postflight). The experiment hardware appears to be without physical damage.

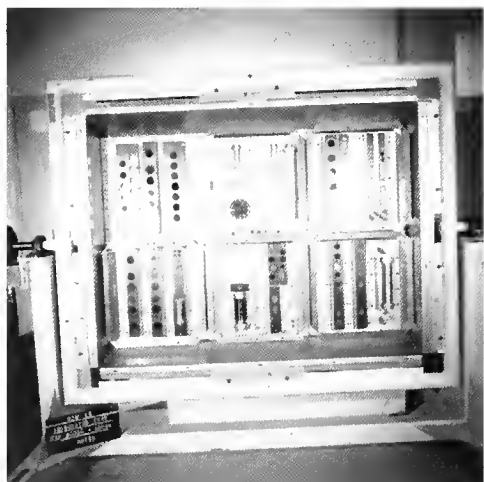
Figure 415
Photo No.: KSC-390C-2114.03
Dup. Neg. No.: L91-10508
LISAR No.: EL-1994-00491
Photo Credit: KSC
Photo Date: 3/20/90
Location: KSC SAEF II
Subject: Postflight Survey of Tray E5

Figure 415 (Postflight). This photograph was taken after the experiment tray was removed from the LDEF and the sun screens were removed. The experiment hardware appears to be without physical damage. The colors of the fiberglass-epoxy mounting strip vary from the typical greenish gray to a slate gray in proportion to their exposure. The red material on top of the aluminum support structure are silicon rubber gaskets between the sun screen and the structure. The gasket material that is missing adhered to the sun screens.

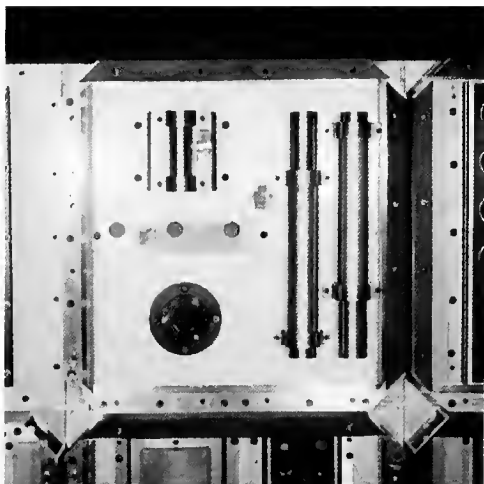
Figure 416 (Postflight). This photograph is of the upper center one-sixth of the tray. The experiment hardware is without physical damage.

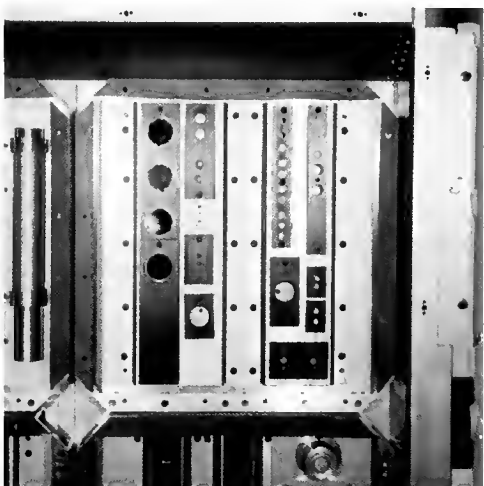
Figure 417 (Postflight). This photograph is of the upper right one-sixth of the tray. The experiment hardware is without physical damage.

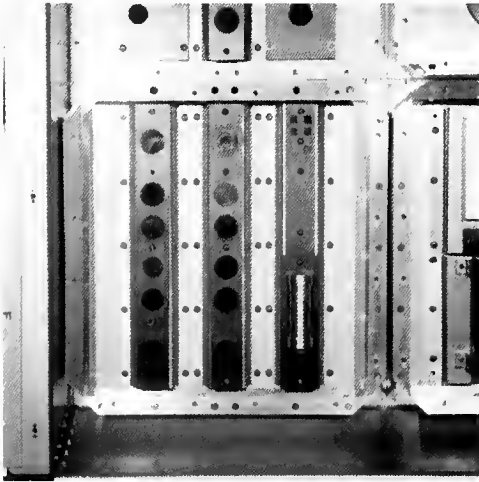
Figure 418 (Postflight). This photograph is of the lower left one-sixth of the tray. The experiment hardware is without physical damage.

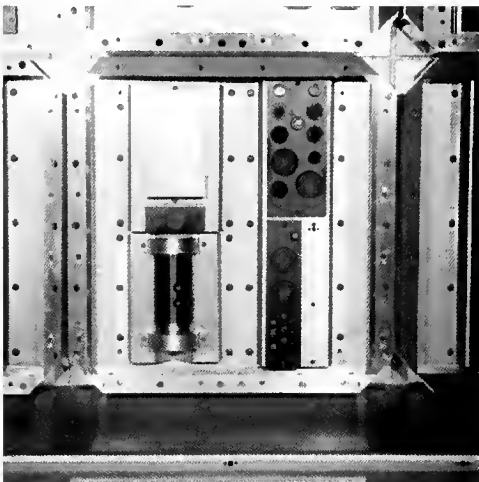
Figure 419 (Postflight). This photograph is of the lower center one-sixth of the tray. The experiment hardware is without physical damage.

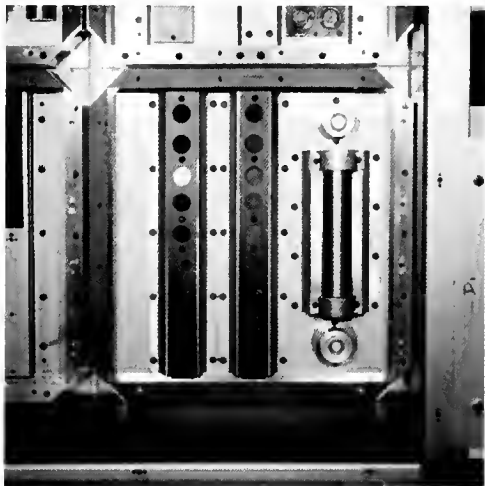
Figure 420 (Postflight). This photograph is of the lower right one-sixth of the tray. The experiment hardware is without physical damage.

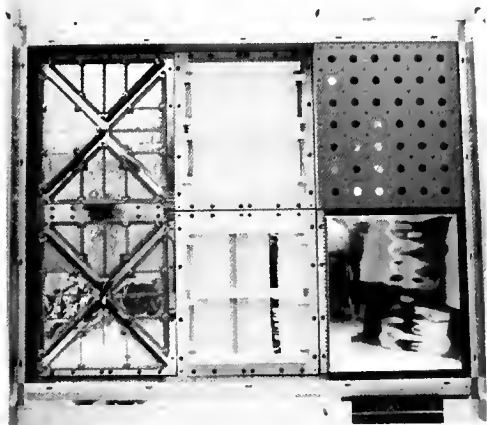
Figure 421
Photo No.: KSC-384C-193.10
Dup. Neg. No.: L84-7068
LISAR No.: EL-1994-00356
Photo Credit: KSC
Photo Date: 1/12/84
Location: KSC SAEF II
Subject: Preflight Survey of Tray E6

Figure 421 (Preflight). In this photograph, experiment AO023, described in figure 230, is shown in the left one-third section. Experiment S1006 occupies the center one-third section. Experiment M0002-2 is in the lower right section. Experiment S1003 is in the top right section of the 3-in-deep tray. Discolorations are visible on the die-cast frames of experiment AO023. Light reflections cause areas of the thin sensor films of experiment AO023 to appear dark.

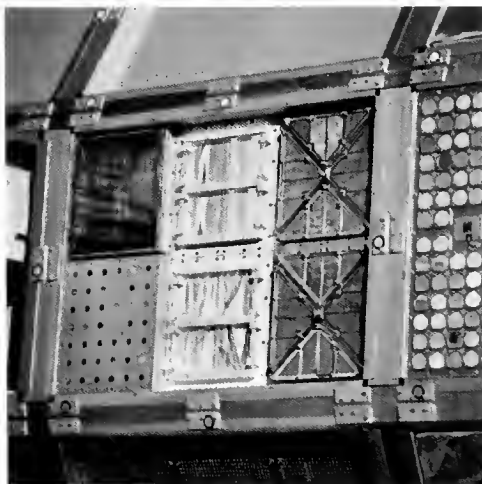
Figure 422
Photo No.: S32-82-006
Dup. Neg. No.: L90-10454
LISAR No.: EL-1994-00024
Photo Credit: JSC
Photo Date: 1/12/90
Location: KSC SAEF II
Subject: In-Flight Survey of Tray E6

Figure 422 (In Flight). The tray clamp dot varies from preflight white at the top to dark brown at the bottom, which is an indication of the transition from leading to trailing side. There are reflections in the foil of the upper sensor of experiment AO023. Low lighting prevents details from being visible in this experiment. The ripples in the Kapton cover foil of experiment M0002-2 that were observed in the prelaunch photograph also appear in the in-flight photographs, but they are at a lower frequency of repetition. The source of discolorations on the aluminized Kapton cover, which appear to be vertical scratches, is unknown. The hardware for experiment S1003 appears to be intact with little or no damage to experiment samples. Many material samples in experiment S1006 have been severely degraded and the base plate is discolored.

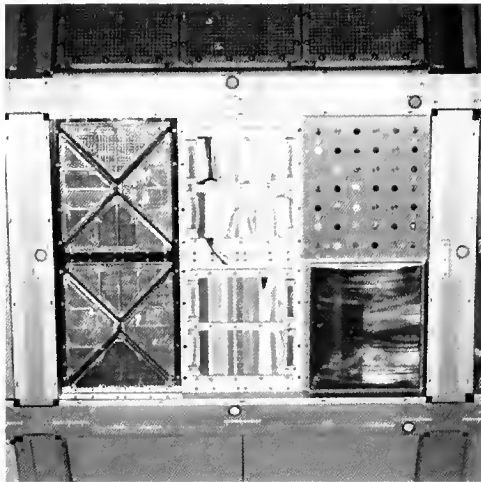
Figure 423 (Postflight). Experiment AO023 has no visible physical damage, but the die-cast frames have discolorations. The detector assemblies of experiment M0002-2 appear to be without physical damage. The source of the discolorations on the aluminized Kapton cover, which appear as horizontal scratches and vertical bands, is unknown. The hardware of experiment S1003 appears to be intact and experiment samples appear to have only minor changes. Many of the material samples in experiment S1006 seem to have severely degraded and the base plate is discolored.

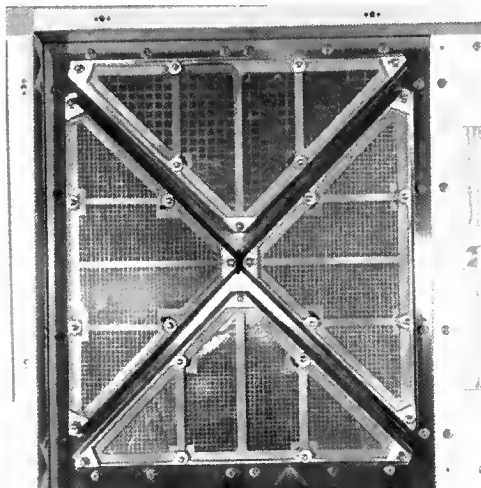
Figure 424 (Postflight). This photograph is of the upper left one-sixth of the tray. The hardware of experiment AO023 is intact. Light reflections are evident in the sensor foil surfaces. There is discoloration on the upper triangular die-cast mounting frame.

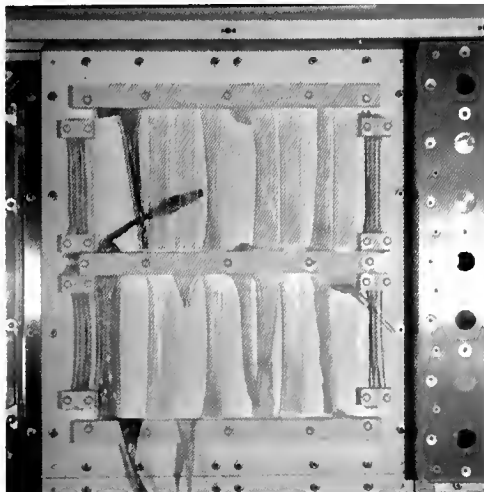
Figure 425
Photo No.: KSC-390C-1992.05
Dup. Neg. No.: L91-10539
LISAR No.: EL-1994-00414
Photo Credit: KSC
Photo Date: 3/15/90
Location: KSC SAEF II
Subject: Postflight Detail of Upper Center of
Tray E6

Figure 425 (Postflight). This photograph is of the upper center one-sixth of the tray. The thin-film polymeric material samples in experiment S1006 have been severely degraded. All 26 of the unreinforced thin-film samples have curled edges. Twelve samples appear to have failed in tension and a significant portion of the two aluminized polymer samples appears to be missing. The IITRI S13G-LO white paint on the baseplate has a light tan discoloration.

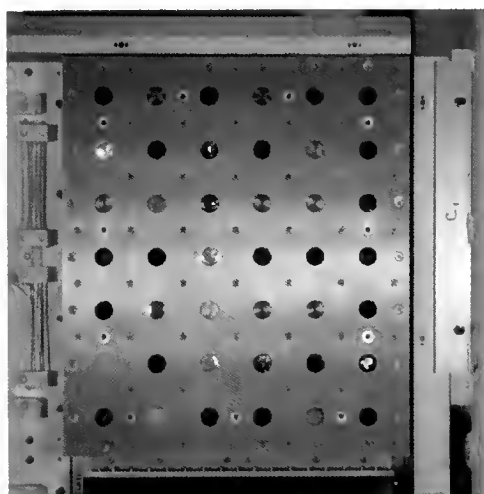
Figure 426
Photo No.: KSC-390C-1992.06
Dup. Neg. No.: L91-10540
LISAR No.: EL-1994-00415
Photo Credit: KSC
Photo Date: 3/15/90
Location: KSC SAEF II
Subject: Postflight Detail of Upper Right of Tray E6

Figure 426 (Postflight). This photograph is of the upper right one-sixth of the tray. The hardware of experiment S1003 is without physical damage and experiment samples have only minor changes. The IITRI S13G-LO white paint sample located second to the right of the lower left corner has changed to light brown and the material sample located second above the lower right corner is partially missing. Other material samples appear in prelaunch condition.

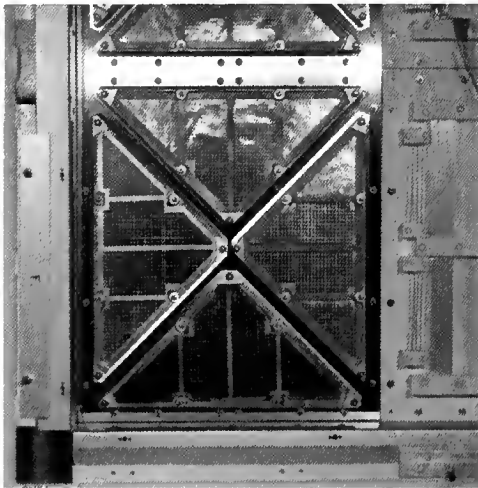
Figure 427 (Postflight). This photograph is of the lower left one-sixth of the tray. The hardware of experiment AO023 is intact. Light reflections are evident in the sensor foil surfaces.

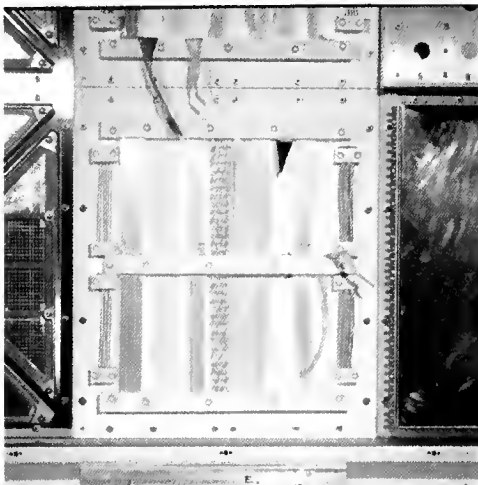
Figure 428 (Postflight). This photograph is of the lower center one-sixth of the tray. The test specimens of experiment S1006 have suffered some degradation. The reinforced thin-film polymer samples are discolored, but they have survived the mission intact. The IITRI S13G-LO white paint on the baseplate has a light tan discoloration in areas that were not covered by experiment samples (with evidence that at least some of the discoloration occurred after sample failure).

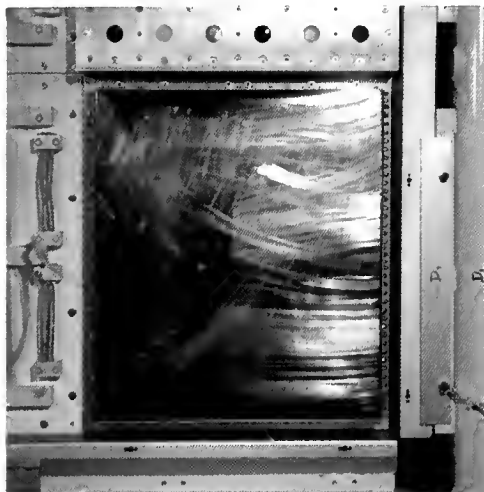
Figure 429 (Postflight). This photograph is of the lower right one-sixth of the tray. Photographic light reflections in the surface are apparent. The experiment appears to have no physical damage from the extended space exposure. The source of discolorations on the aluminized Kapton cover, which appear as horizontal scratches and vertical shadows, is unknown.

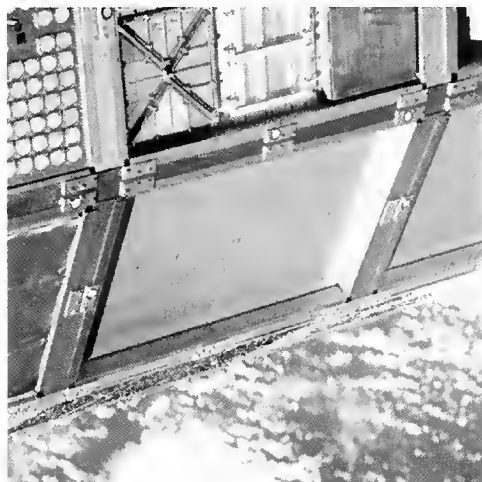
Figure 430 (In Flight). The discolorations on the lower tray sidewall appear to be fingerprints from handling during experiment assembly. A portion of the pink and greenish-gray tint on the two debris panels are a by-product of the chromic anodize coating process; however, a part of the intensity can be attributed to reflections of the blue sky. The horizontal streaks on the left debris panel and the vertical streaks on the right debris panel are also by-products of chromic anodizing that have been enhanced significantly by the blue reflection.

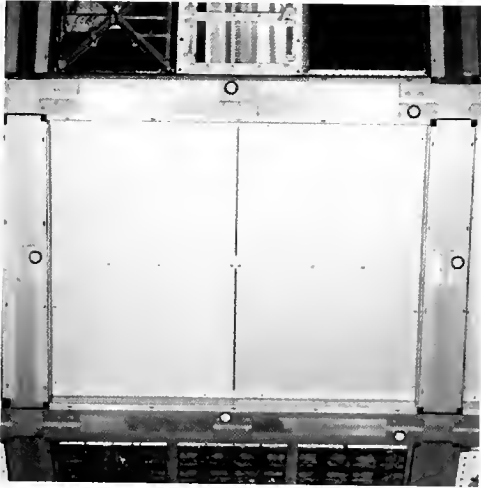
Figure 431
Photo No.: KSC-390C-1032.03
Dup. Neg. No.: L90-13425
LISAR No.: EL-1994-00148
Photo Credit: KSC
Photo Date: 2/9/90
Location: KSC SAEF II
Subject: Postflight Survey of Tray E7

Figure 431 (Postflight). The pink and greenish-gray tints on the two debris panels are by-products of the chromic anodize coating process and are not attributed to contamination or exposure to the space environment. The streaks on the debris panels that were noted in the in-flight photographs are almost invisible because the reflection of the sky is not present. The light band along the sides and across the bottom of the panels is caused by light reflecting from the tray sidewalls.

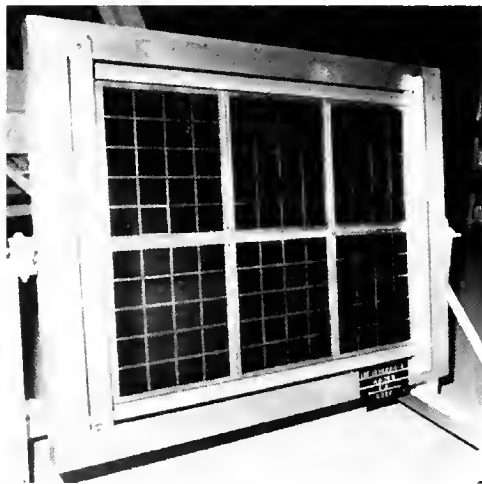
Figure 432 (Preflight). The prelaunch photograph shows 120 capture cells installed on 6 support panels. A capture cell consists of four polished high-purity germanium plates covered with a 2.5- μm thick Mylar foil coated with 1300 Å of tantalum that is vapor deposited on the back and 100 Å of gold-palladium that is vapor deposited on the front. The capture cells are mounted within an aluminum frame on each panel.

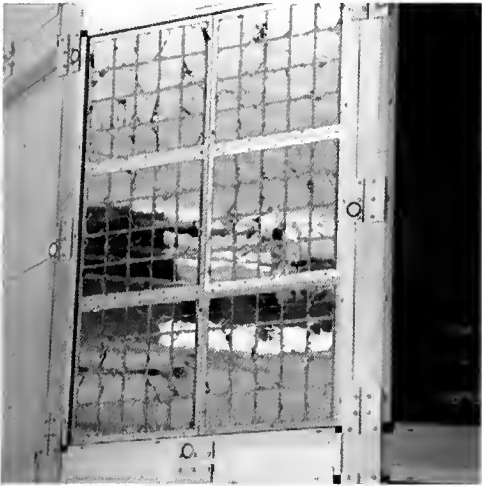
Figure 433
Photo No.: S32-76-016
Dup. Neg. No.: L90-10378
LISAR No.: EL-1994-00663
Photo Credit: JSC
Photo Date: 1/12/90
Location: In Flight
Subject: In-Flight Survey of Tray E8

Figure 433 (In Flight). The RMS arm of the Shuttle is reflected in the surface of the exposed germanium detector plates. The experiment has severely degraded. The metallic-coated Mylar film covers have failed on each of the capture cells and curled tightly into conical shapes.

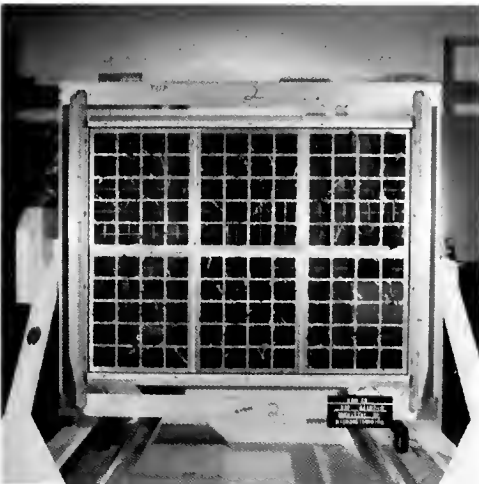
Figure 434
Photo No.: KSC-390C-1767.02
Dup. Neg. No.: L91-10614
LISAR No.: EL-1994-00267
Photo Credit: KSC
Photo Date: 3/90/90
Location: KSC SAEF II
Subject: Postflight Survey of Tray E8

Figure 434 (Postflight). The metallic-coated thin Mylar film has been lost on each of the capture cells. As the thin Mylar film failed, the material curled tightly into small conical shapes and is still attached to the edges of the aluminum mounting structure. The green tint on the germanium plate at the right edge of the experiment tray is a reflection from the lights in the high bay area of SAEF II. Dim reflections are visible on other sections of the experiment.

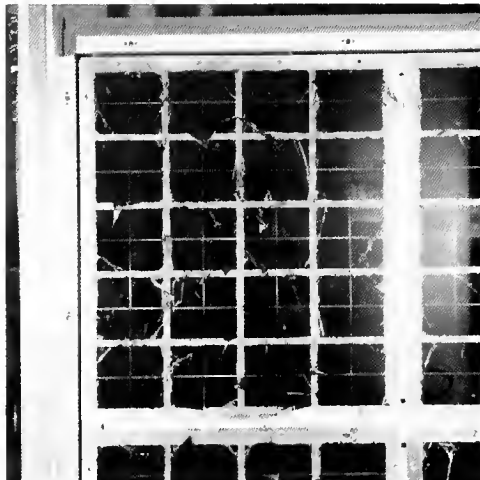
Figure 435 (Postflight). This photograph is of the upper left one-sixth of the tray. The metallic-coated thin Mylar film on all cells has failed and the remnants of the film are hanging loose. A reflection of the surrounding area in the surface of the germanium plates is visible.

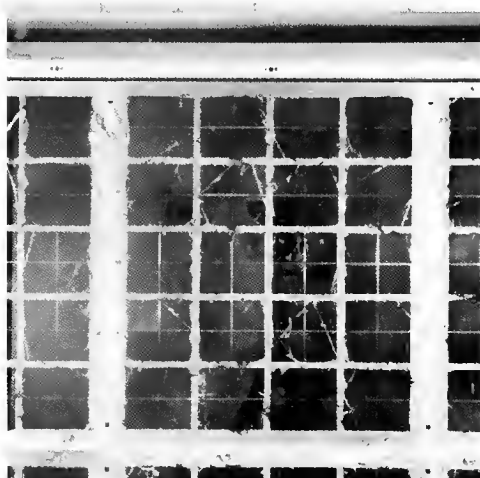
Figure 436 (Postflight). This photograph is of the upper center one-sixth of the tray. The metallic-coated thin Mylar film on all cells has failed and the remnants of the film are hanging loose. A reflection of the surrounding area in the surface of the germanium plates is visible.

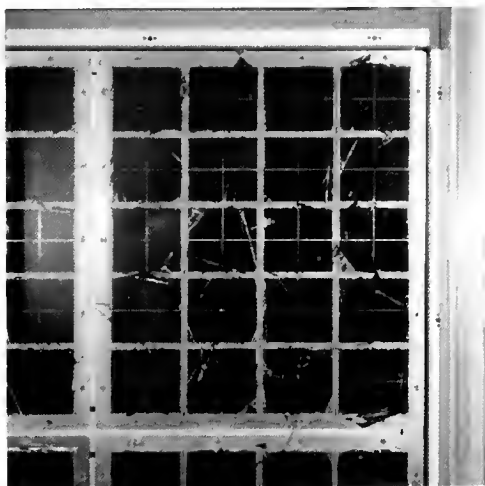
Figure 437 (Postflight). This photograph is of the upper right one-sixth of the tray. The metallic-coated thin Mylar film on all cells has failed and the remnants of the film are hanging loose. A reflection of the surrounding area in the surface of the germanium plates is visible.

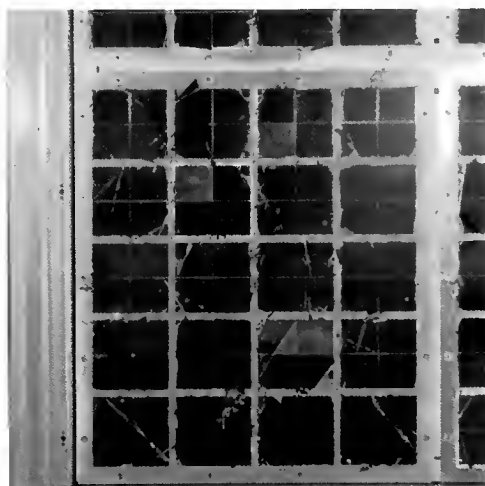
Figure 438 (Postflight). This photograph is of the lower left one-sixth of the tray. The metallic-coated thin Mylar film on all cells has failed and the remnants of the film are hanging loose. A reflection of the surrounding area in the surface of the germanium plates is visible.

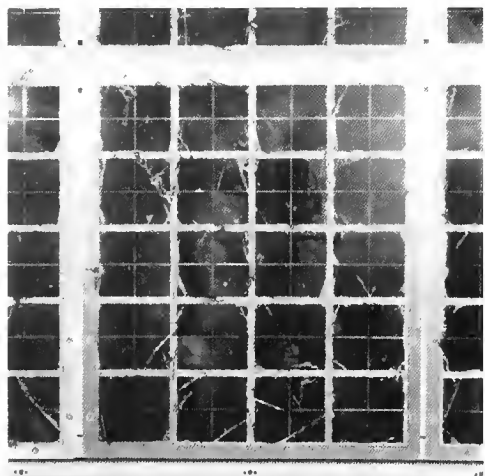
Figure 439 (Postflight). This photograph is of the lower center one-sixth of the tray. The metallic-coated thin Mylar film on all cells has failed and the remnants of the film are hanging loose. A reflection of the surrounding area in the surface of the germanium plates is visible.

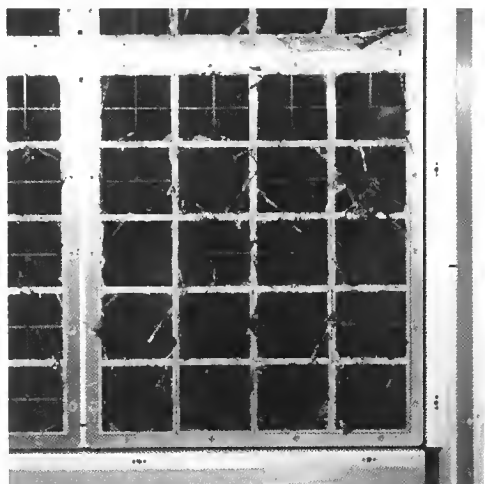
Figure 440 (Postflight). This photograph is of the lower right one-sixth of the tray. The metallic-coated thin Mylar film on all cells has failed and the remnants of the film are hanging loose. A reflection of the surrounding area in the surface of the germanium plates is visible.

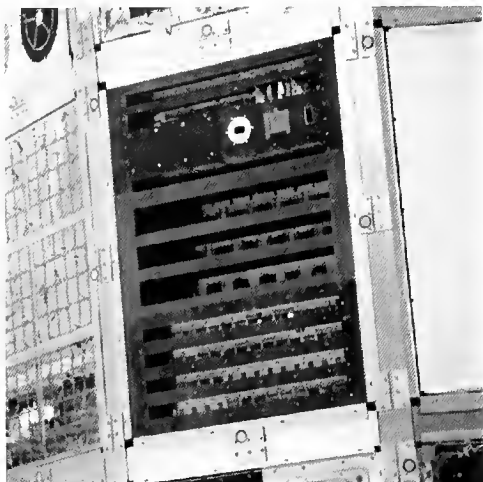
Figure 442
Photo No.: S32-78-090
Dup. Neg. No.: L90-10449
LISAR No.: EL-1994-00021
Photo Credit: JSC
Photo Date: 1/12/90
Location: In Flight
Subject: In-Flight Survey of Tray E9

Figure 442 (In Flight). The Chemglaze Z-306 black paint on the exposed surfaces has degraded, thus leaving the Chemglaze 9924 primer, which is reddish brown, clearly visible. The difference in the amount of paint remaining may be a function of initial paint thickness; the plate covering the center section was not painted at the same time as the other two plates. The experiment appears intact with little, if any damage.

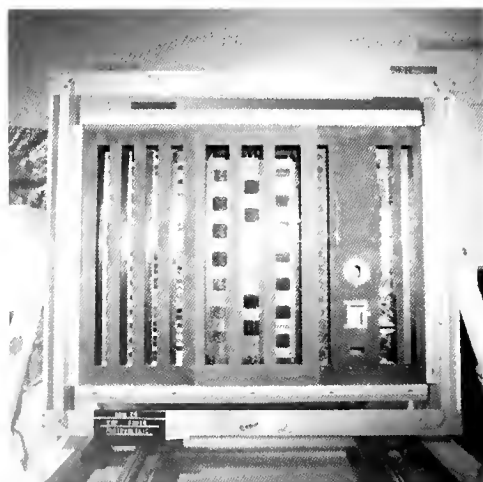
Figure 443
Photo No.: KSC-390C-1840.10
Dup. Neg. No.: L91-10676
LISAR No.: EL-1994-00279
Photo Credit: KSC
Photo Date: 3/12/90
Location: KSC SAEF II
Subject: Postflight Survey of Tray E9

Figure 443 (Postflight). The degradation of the Chemglaze Z-306 black paint on the exposed surfaces is evident by the amount of Chemglaze 9924 primer, which is reddish brown, that is visible. The difference in the amount of paint remaining may be a function of initial paint thickness; the plate covering the center section of the tray was not painted at the same time as the other two plates. The small gold-colored rectangular plate in the lower right section of the tray was fabricated from an aluminum alloy and coated with a clear anodize. A light brown discoloration is visible on the solar cell mounting plates and on areas of the aluminum base structure.

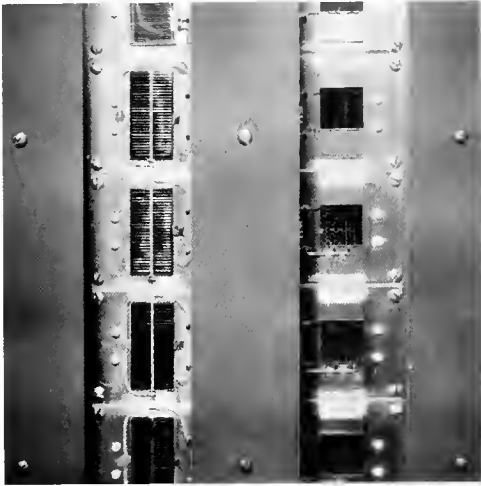
Figure 444 (Postflight). This close-up photograph is of the two left rows. No physical damage is evident.

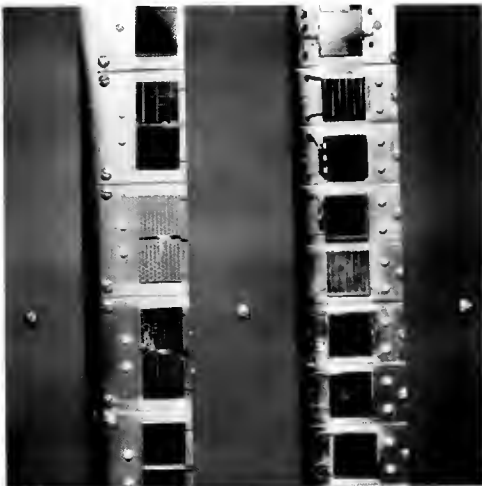
Figure 445 (Postflight). This close-up photograph is of the third and the fourth rows. No physical damage is evident.

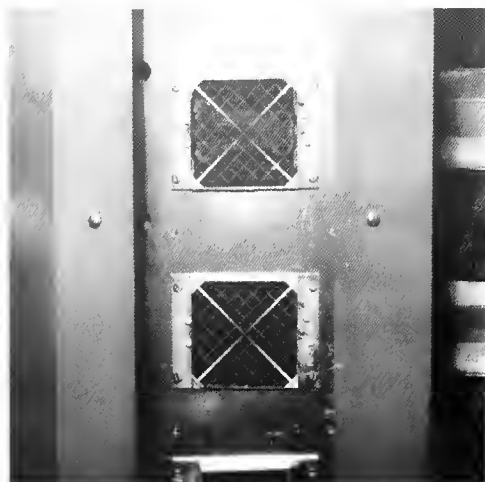
Figure 446
Photo No.: KSC-390C-1835.02
Dup. Neg. No.: L91-10633
LISAR No.: EL-1994-00398
Photo Credit: KSC
Photo Date: 3/12/90
Location: KSC SAEF II
Subject: Postflight Detail of Fifth Row of Tray E9

Figure 446 (Postflight). This close-up photograph is of the fifth row. There appears to be no physical damage, but some brown discoloration around the edges of the solar cells is evident.

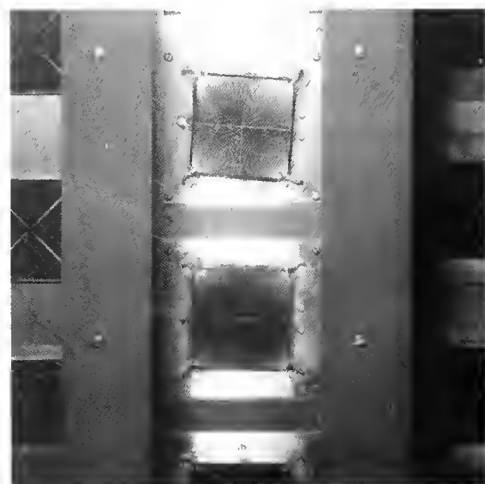
Figure 447
Photo No.: KSC-390C-1835.05
Dup. Neg. No.: L91-10636
LISAR No.: EL-1994-00399
Photo Credit: KSC
Photo Date: 3/12/90
Location: KSC SAEF II
Subject: Postflight Detail of Sixth Row of Tray E9

Figure 447 (Postflight). This close-up photograph is of the sixth row. There appears to be no physical damage, but some brown discoloration around the edges of the solar cells is evident.

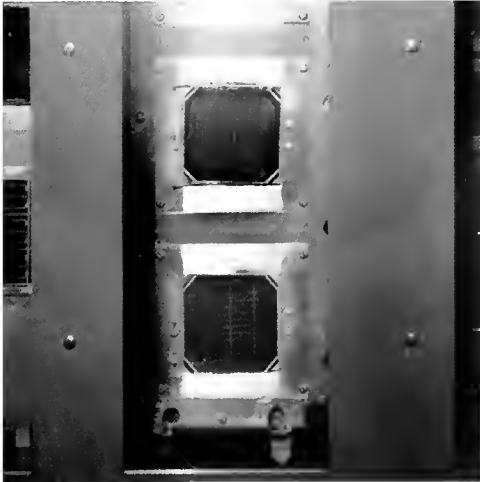
Figure 448
Photo No.: KSC-390C-1835.09
Dup. Neg. No.: L91-10640
LISAR No.: EL-1994-00400
Photo Credit: KSC
Photo Date: 3/12/90
Location: KSC SAEF II
Subject: Postflight Detail of Seventh Row of
Tray E9

Figure 448 (Postflight). This close-up photograph is of the seventh row. There appears to be no physical damage, but some brown discoloration around the edges of the solar cells is evident.

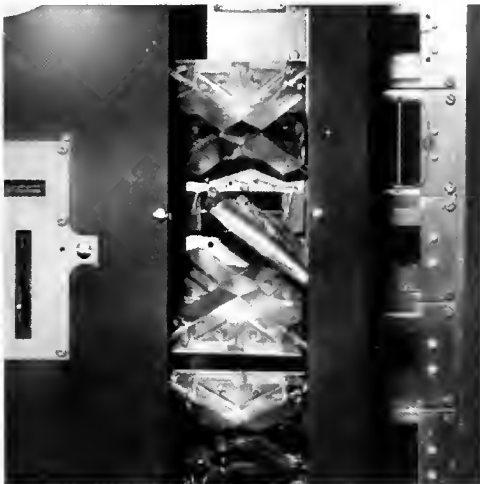
Figure 449
Photo No.: KSC-390C-1837.07
Dup. Neg. No.: L91-10657
LISAR No.: EL-1994-00402
Photo Credit: KSC
Photo Date: 3/12/90
Location: KSC SAEF II
Subject: Postflight Detail of Ninth Row of Tray E9

Figure 449 (Postflight). This close-up is of the ninth row. A solar concentrator cell, located at the lower end of the slot, appears to be damaged. The large piece of gold-colored material lodged in the slot appears to be a segment of the aluminum deposited on the Kapton mirror.

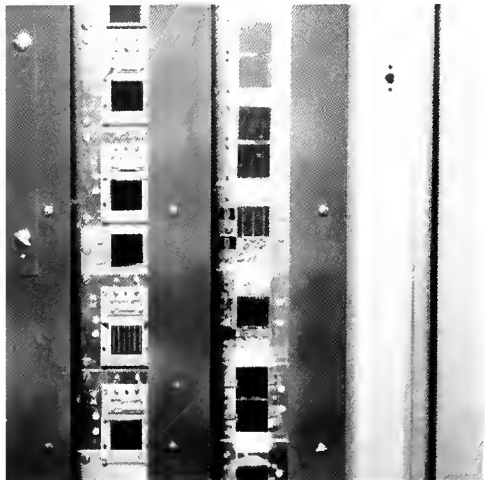
Figure 450 (Postflight). This close-up photograph is of the tenth row. There appears to be no physical damage, but the cell mounting frames have a mottled brown discoloration.

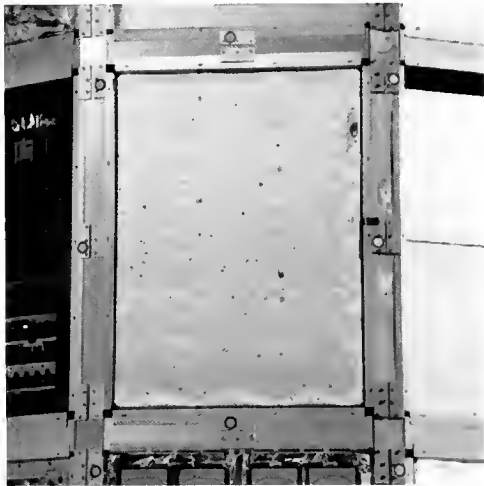
Figure 451 (In Flight). The surface of the thermal cover appears to have changed from specular to opaque with numerous black dots of various sizes, thus indicating impacts or penetrations. The cover is taut and the locations of Velcro attachment pads are prominent. The ground strap has no visible damage, but is a deeper copper color.

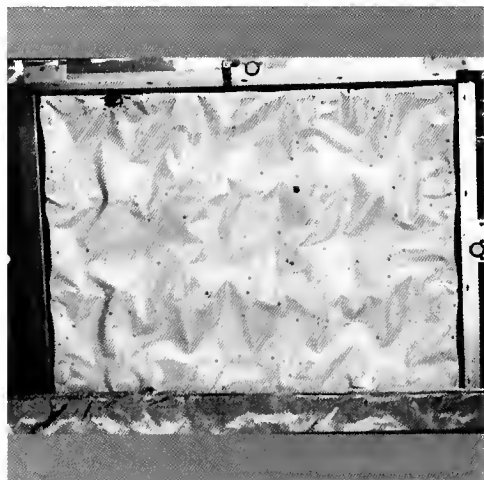
Figure 452
Photo No.: KSC-390C-612.05
Dup. Neg. No.: L92-17796
LISAR No.: EL-1994-00162
Photo Credit: KSC
Photo Date: 1/30/90
Location: KSC OPF
Subject: Postflight Survey of Tray E10

Figure 452 (Postflight). The surface of the thermal cover appears to have changed from specular to opaque with numerous black dots of various sizes, thus indicating space debris impacts or penetrations. The cover is less taut than in flight. The locations of Velcro attachment pads are visible. The pinkish green tint on the thermal cover is caused by the lighting and reflections from the surroundings. The arm of the RMS that is cradled in the Shuttle is visible at the bottom.

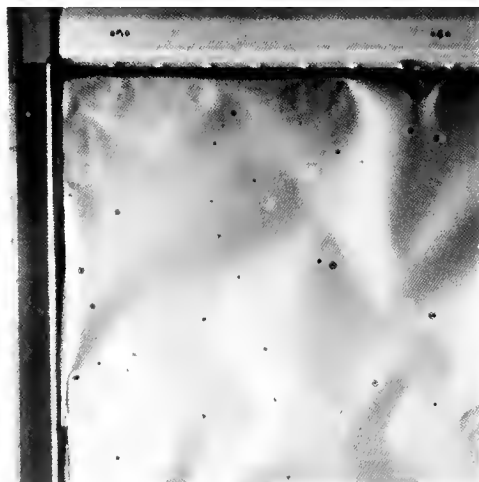
Figure 453
Photo No.: KSC-390C-2281.02
Dup. Neg. No.: L91-10711
LISAR No.: EL-1994-00620
Photo Credit: KSC
Photo Date: 3/23/90
Location: KSC SAEF II
Subject: Postflight Detail of Upper Left of Tray E10

Figure 453 (Postflight). This photograph is of the upper left one-sixth of the tray. The thermal cover is now opaque and not as highly reflective as it was in the preflight photograph. There are numerous black dots of various sizes that indicate space debris impacts or penetrations. The thermal cover Velcro attachment pads are evident.

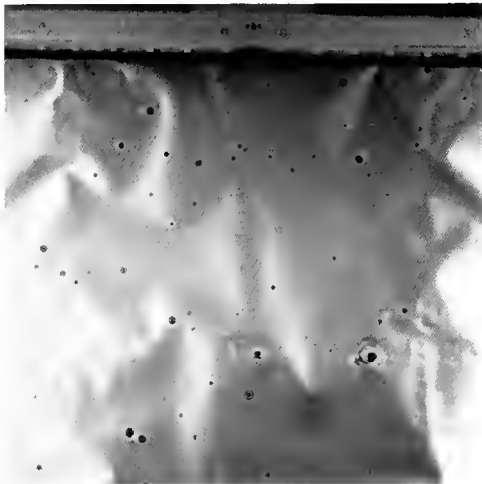
Figure 454
Photo No.: KSC-390C-2281.03
Dup. Neg. No.: L91-10712
LISAR No.: EL-1994-00561
Photo Credit: KSC
Photo Date: 3/23/90
Location: KSC SAEF II
Subject: Postflight Detail of Upper Center of
Tray E10

Figure 454 (Postflight). This photograph is of the upper center one-sixth of the tray. The thermal cover is now opaque and not as highly reflective as it was in the preflight photograph. There are numerous black dots of various sizes that indicate space debris impacts or penetrations. The thermal cover Velcro attachment pads are evident.

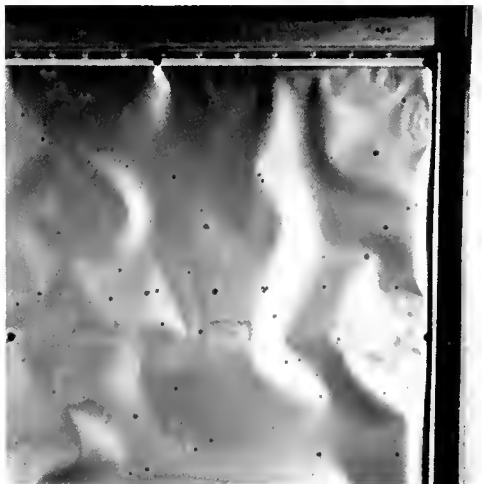
Figure 455
Photo No.: KSC-390C-2281.04
Dup. Neg. No.: L91-10713
LISAR No.: EL-1994-00562
Photo Credit: KSC
Photo Date: 3/23/90
Location: KSC SAEF II
Subject: Postflight Detail of Upper Right of
Tray E10

Figure 455 (Postflight). This photograph is of the upper right one-sixth of the tray. The thermal cover is now opaque and not as highly reflective as it was in the preflight photograph. There are numerous black dots of various sizes that indicate space debris impacts or penetrations. The thermal cover Velcro attachment pads are evident.

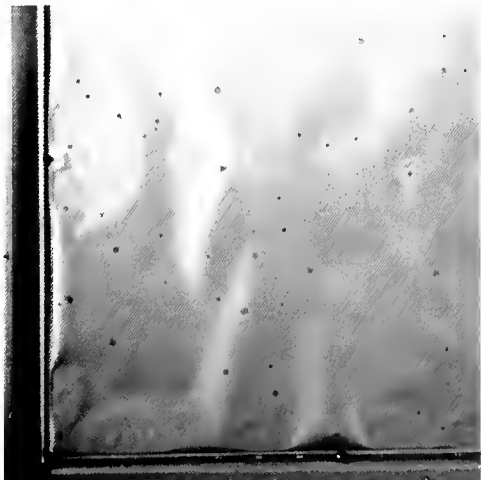
Figure 456 (Postflight). This photograph is of the lower left one-sixth of the tray. The thermal cover is now opaque and not as highly reflective as it was in the preflight photograph. There are numerous black dots of various sizes that indicate space debris impacts or penetrations. The thermal cover Velcro attachment pads are evident.

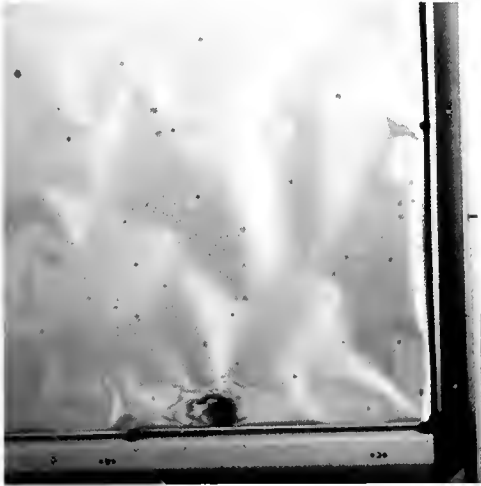
Figure 458
Photo No.: KSC-390C-2281.10
Dup. Neg. No.: L91-10719
LISAR No.: EL-1994-00565
Photo Credit: KSC
Photo Date: 3/23/90
Location: KSC SAEF II
Subject: Postflight Detail of Lower Right of
Tray E10

Figure 458 (Postflight). This photograph is of the lower right one-sixth of the tray. The thermal cover is now opaque and not as highly reflective as it was in the preflight photograph. There are numerous black dots of various sizes that indicate space debris impacts or penetrations. The thermal cover Velcro attachment pads are evident.

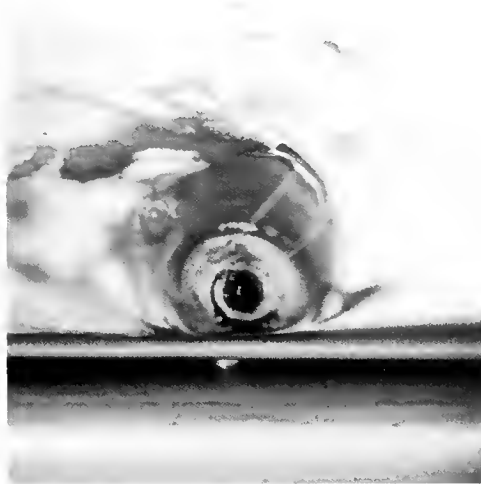
Figure 459
Photo No.: KSC-390C-2281.11
Dup. Neg. No.: L91-10720
LISAR No.: EL-1994-00566
Photo Credit: KSC
Photo Date: 3/23/90
Location: KSC SAEF II
Subject: Postflight Detail of Discoloration in Lower
Right of Tray E10

Figure 459 (Postflight). This close-up photograph is of the large discolored area at the edge of the thermal cover near the lower right corner of the tray.

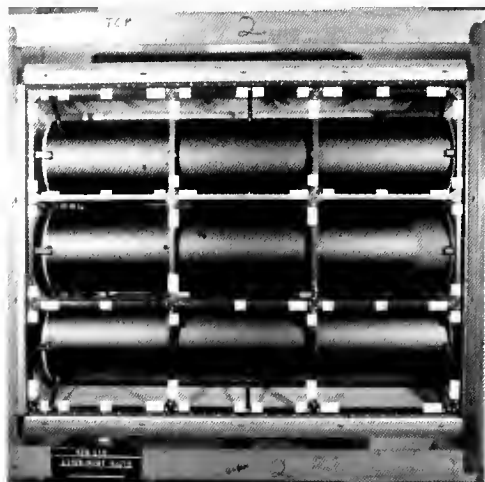
Figure 460 (Postflight). This photograph is of tray E10 after the thermal cover has been removed. Note the spots visible on the upper cylinders. These discolorations occurred behind penetrations of the thermal cover. The frame with the Velcro pads for attaching the thermal cover is visible.

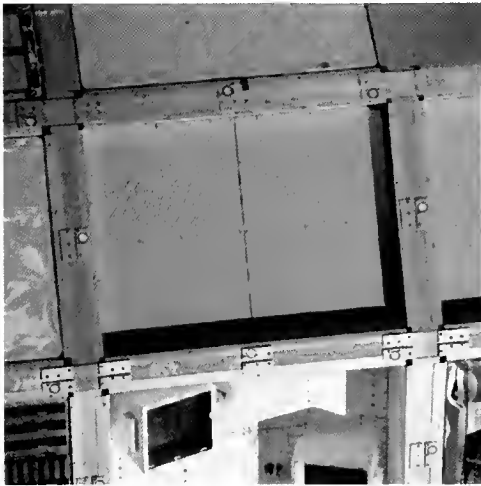
Figure 461 (In Flight). A portion of the pink and greenish-gray tint on the two debris panels is a by-product of the chromic anodize coating process; however, part of the intensity can be attributed to reflections of the blue sky. The vertical streaks on the debris panel are by-products of chromic anodizing that have been enhanced by the blue reflection. The light band along the vertical edge of the left debris panel is a reflection from the tray sidewall.

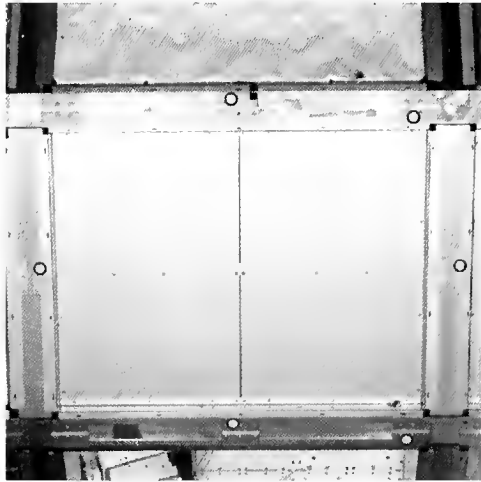
Figure 462 (Postflight). The pink and greenish-gray tints on the two debris panels are by-products of the chromic anodize coating process and are not attributed to contamination or exposure to the space environment. The vertical streaks observed on the debris panels in the in-flight photograph are no longer visible because the reflection of the sky is not present. Debris from other experiments that were significantly degraded during the mission are visible on the lower experiment tray sidewall at the intersection with the lower edge of the debris panels. Other experiment debris, visible as dark specks, are at the intersection of the debris panel outer edges and the tray sidewalls. The light band along the sides and across the bottom of the panels is caused by light reflecting from the tray sidewalls.

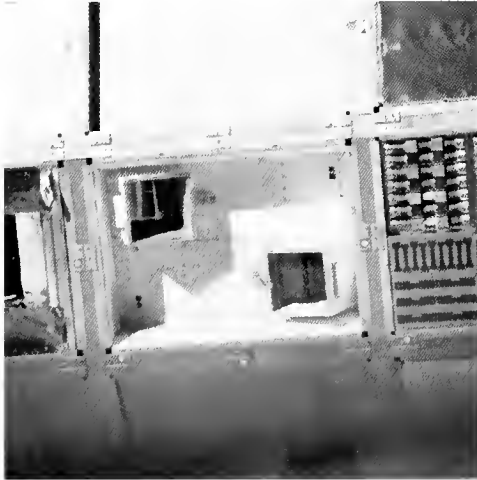
Figure 464
Photo No.: S32-78-031
Dup. Neg. No.: L90-10431
LISAR No.: EL-1994-00007
Photo Credit: JSC
Photo Date: 1/12/90
Location: In Flight
Subject: In-Flight Survey of Tray E12

Figure 464 (In Flight). The color of the thermal control paint on experiment AO038 has changed and now varies from white to shades of brown. The shadows from the tray sidewalls hide most of the dark stain in the upper right corner of the tray.

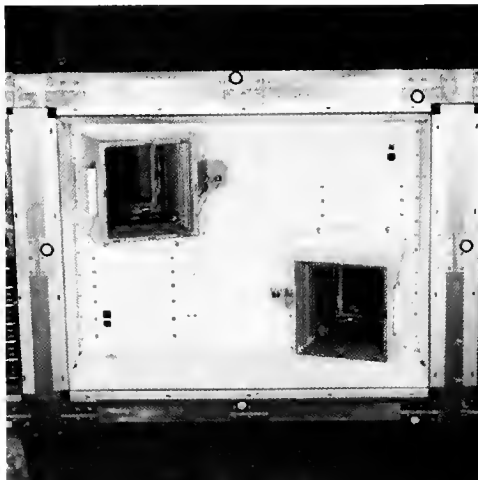
Figure 465
Photo No.: KSC-390C-1069.09
Dup. Neg. No.: L90-13489
LISAR No.: EL-1994-00201
Photo Credit: KSC
Photo Date: 2/8/90
Location: KSC SAEF II
Subject: Postflight Survey of Tray E12

Figure 465 (Postflight). Brown stains are prominent, especially around the openings in the baseplate for the grid voltage cable connectors. The beryllium copper collector foils are clearly visible in this photograph, as are the baffles near the top of the canister housing. However, the fine wire mesh grid is not visible. Because of an experiment system malfunction, the canister collector foils that are visible were exposed for the total mission.

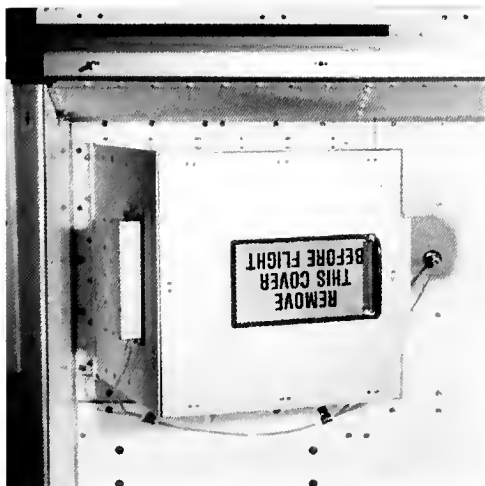
Figure 466 (Postflight). This photograph is of the upper left one-sixth of the tray. Note the brown discoloration in the tray corner and around the grid voltage plug to the right of the canister. The cover was installed on the canister housing to protect the space-exposed hardware.

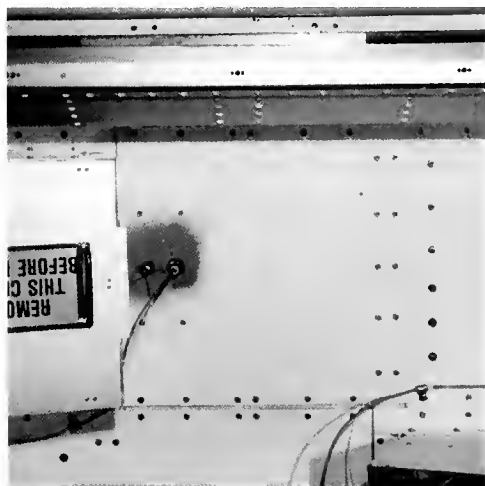
Figure 467 (Postflight). This photograph is of the upper center one-sixth of the tray. Note the brown discoloration around the grid voltage plug to the right of the canister. The cover was installed on the canister housing to protect the space-exposed hardware.

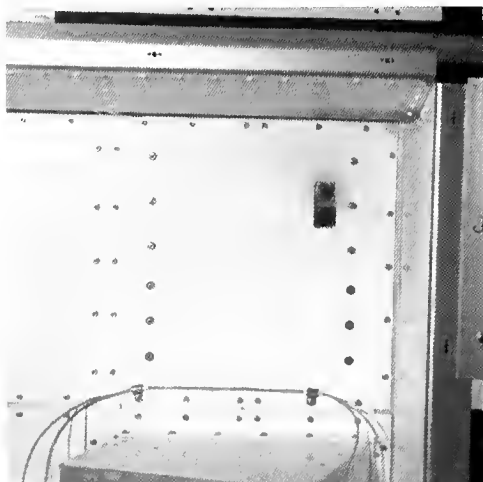
Figure 468 (Postflight). This photograph is of the upper right one-sixth of the tray. Note the light brown discoloration in the tray corner.
